Detection of a defect on the back of a pipe by non-contact remote measurements

Takahiro Hayashi

Graduate School of Engineering, Kyoto University
Kyoto-daigaku Katsura Nishikyo-ku, Kyoto 615-8540, Japan
hayashi@kuaero.kyoto-u.ac.jp

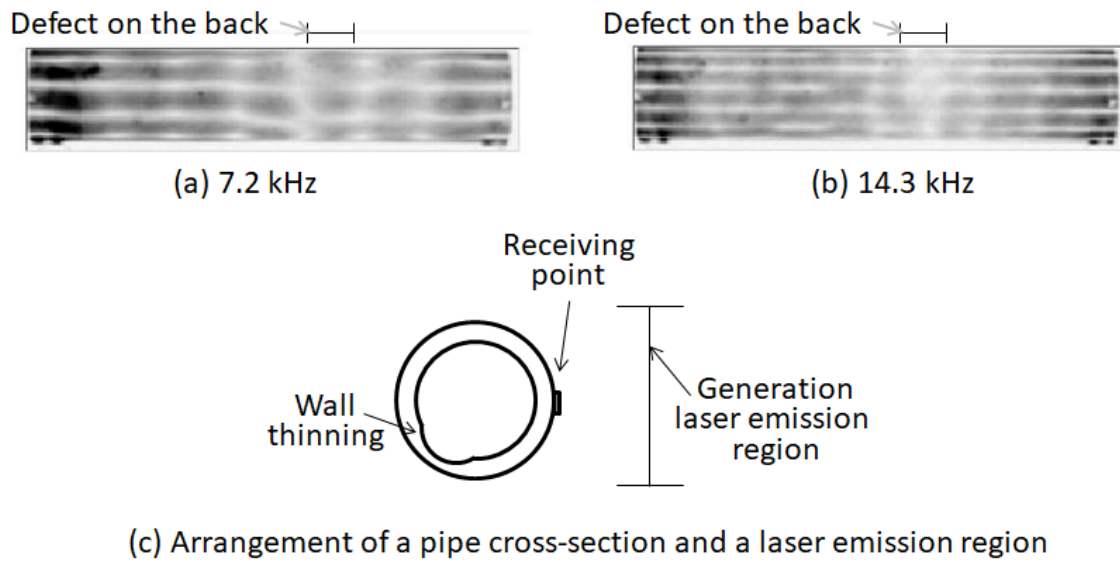
Fig. 12. Sum of distributions of frequency spectrum peak for left and right receiving positions when wall thinning is located at $\theta=235^\circ$.

Figures 12 (a) and (b) are the averaged distributions at 7.2 kHz and 14.3 kHz, respectively, when the defect is located at $\theta = 235^\circ$. These figures were obtained using the same procedures used to obtain Fig. 10 (c) and Fig. 11 (c); only the circumferential locations of the wall thinning were different. These figures show similar tendencies as Fig. 10 (c) and Fig. 11 (c); the vertical patterns are symmetrically distributed from the defect area at 7.2 kHz, and a small intensity region appears at the defect area at 14.3 kHz.
